Manhole Inspection Summary

Manhole # S07YY1011MH

Insp Date: **9/12/06 1:47 PM**

Location Address: **2809 Glen Ave**

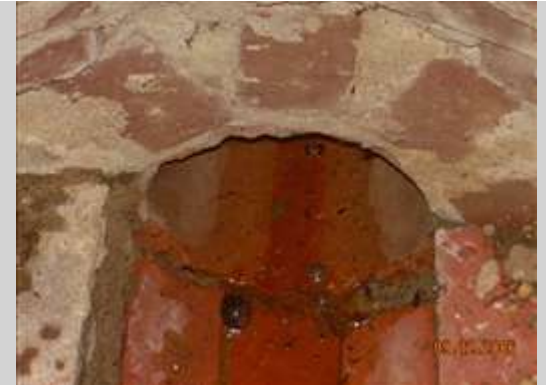
6 in. Circular Gravity Sewer Pipe Out @ 12 O'Clock

Deposits: ☒ None ☐ Mud ☐ Sludge ☐ Debris ☐ Grease

Infiltration: **None** Pipe Seal Cond: **Sound**

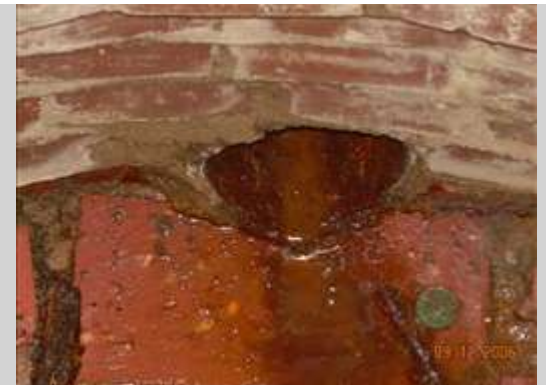
4 in. Circular Gravity Sewer Pipe In @ 6 O'Clock

Deposits: ☒ None ☐ Mud ☐ Sludge ☐ Debris ☐ Grease

Infiltration: **Evidence** Pipe Seal Cond: **Unknown**
